# THE INFLUENCE OF A LARGE REFLECTOR OVER THE ORCHESTRA PIT IN AN OPERA HOUSE

Tor Halmrast  
Anders Buen  
Gunnar Ihlen

Statsbygg, Oslo, Norway [tor.halmrast@statsbygg.no](mailto:tor.halmrast@statsbygg.no)  
Brekke and Strand Acoustics, Oslo, Norway  
Norwegian National Opera, Oslo, Norway

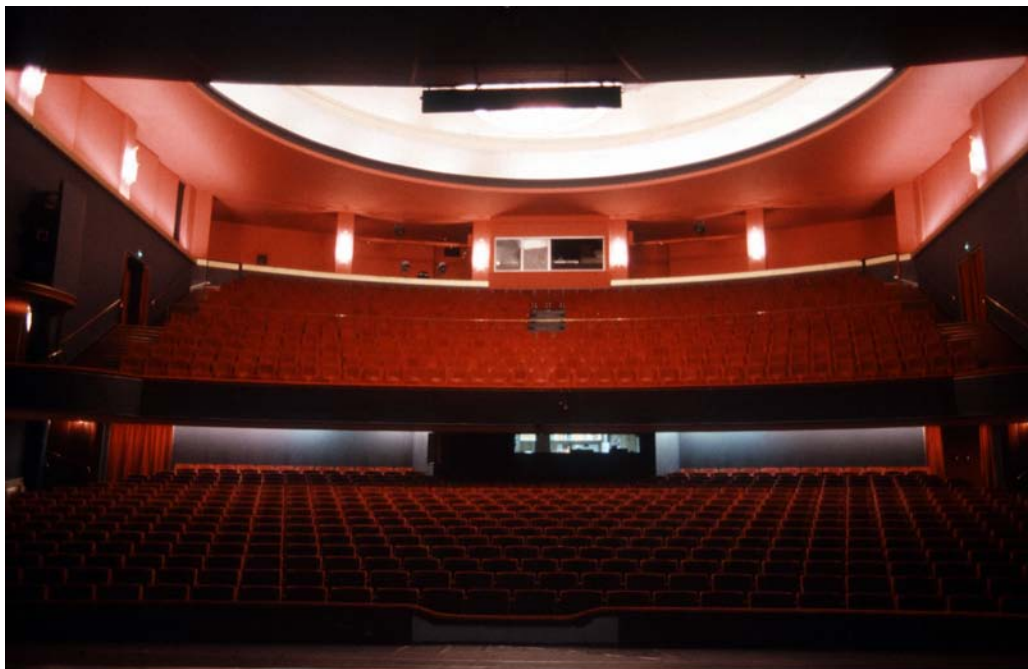
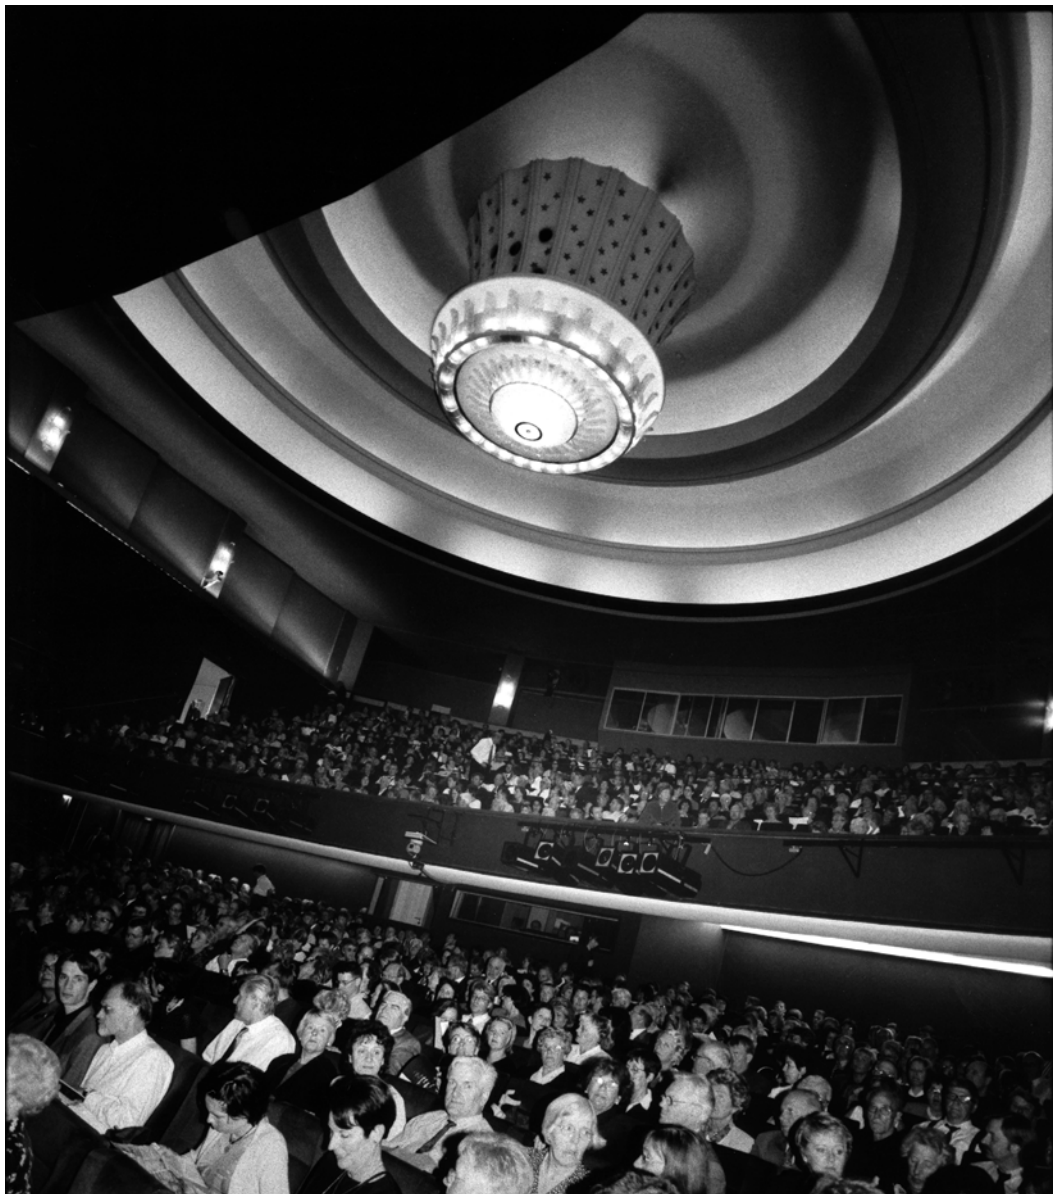
The following pictures show that the OLD, large reflector shaded a large part of the ceiling.

*(Ceiling made in rabbitz, visually nice/acoustically strange)*
