Korundi – The new home for the Lapland chamber orchestra

Henrik Möller

Akukon Ltd, Sliperivägen 19, FIN-00380, Finland,

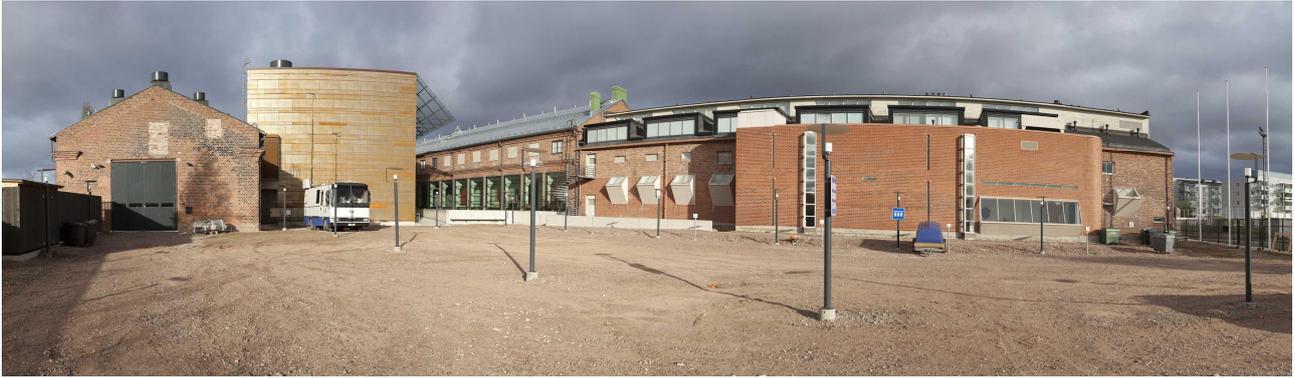
Figure 1: Panoramic view of the court yard of the Korundi Cultural Centre. The concert hall is in the box in the middle.

The first versions of the concert hall were placed inside the southern section of the depot. Soon it however became clear that the best solution was to place the concert hall in a new building, in the courtyard of the depot.

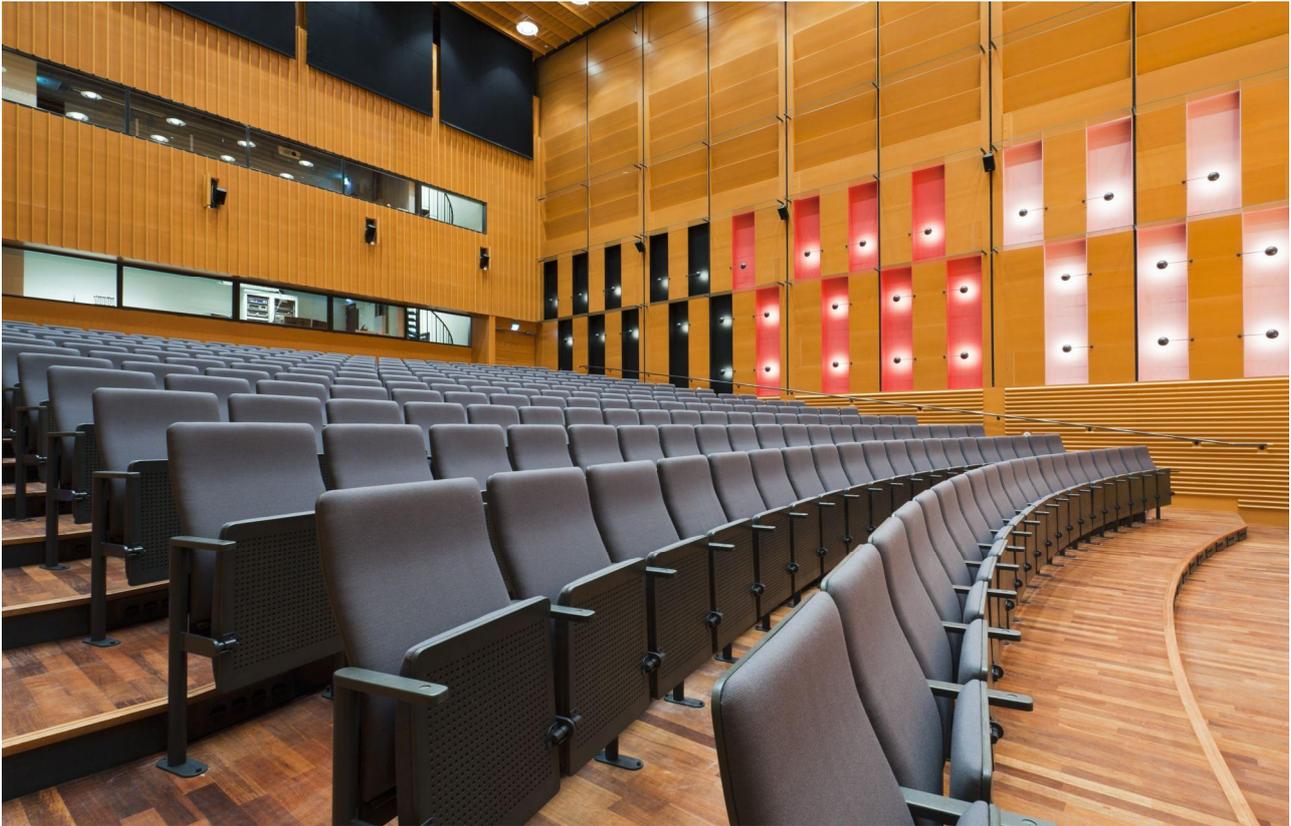
Figure 2: View towards the rear of the hall
(picture courtesy Arto Liiti)

The architectural concept for the concert hall was a minimalist , rectangular “music box”. The main part of the interior surfaces are wood veneer on 12-26 mm thick boards, with the exceptions of the bottom of the “diffuser structures” on the lower part of the side walls, which are painted single or double layer plaster board. There are glass reflector shelves on the side walls, to enhance lateral reflections, and glass plates hanging from the ceiling, to provide reflections back to the stage.

The stage is 45 mm hard pine wood and the floor in the auditorium is parquet fixed directly to the concrete. The seats are lightly upholstered and fold-up when not in use.

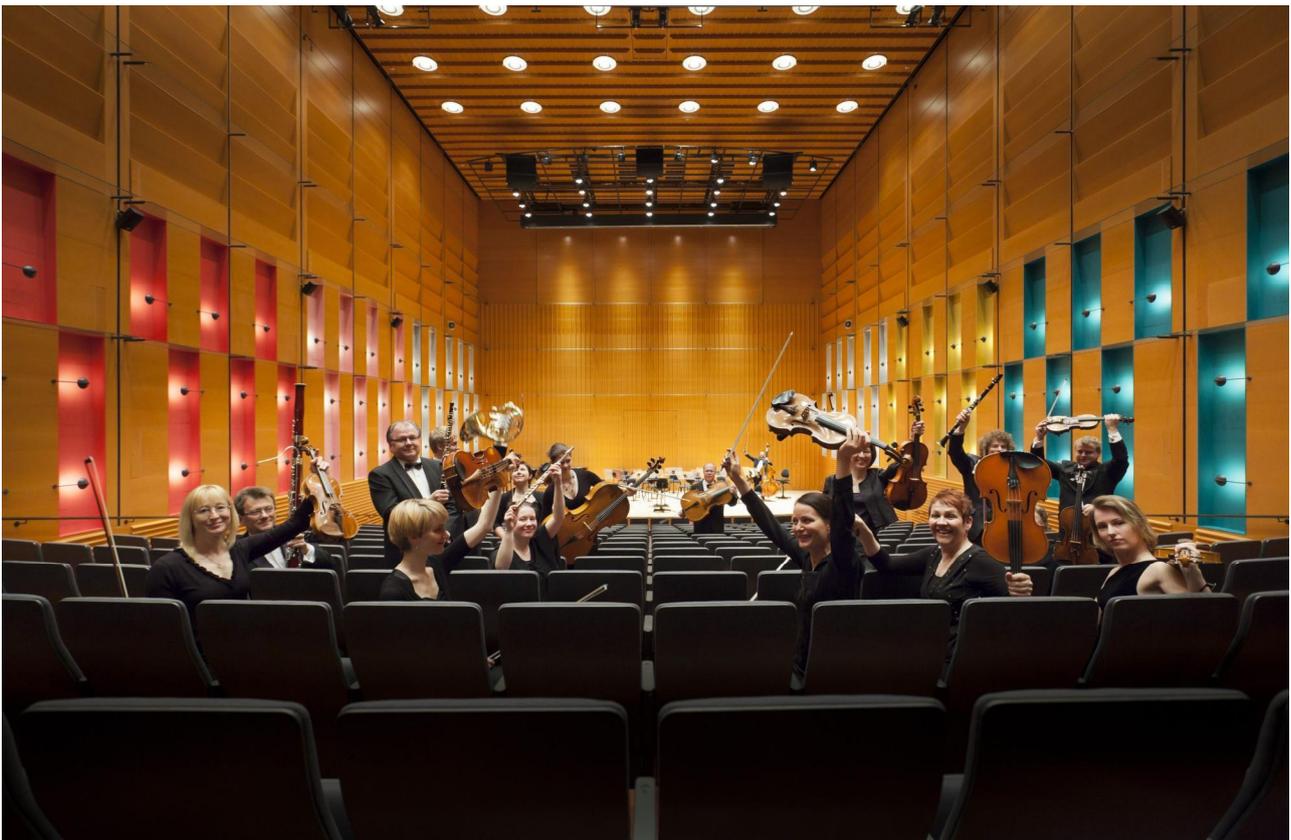
Figure 4: View from the rear of the hall towards the stage, with Lapland Chamber Orchestra (picture courtesy Arto Liiti)

It has taken some trial and error for the orchestra to get used the new stage, in the instruments placed in the rear of the orchestra, as the limited stage depth places them quite close to the backwall.
